Utilities Department News

Fall 2014

Sellers WRF receives major renovation of headworks and odor control

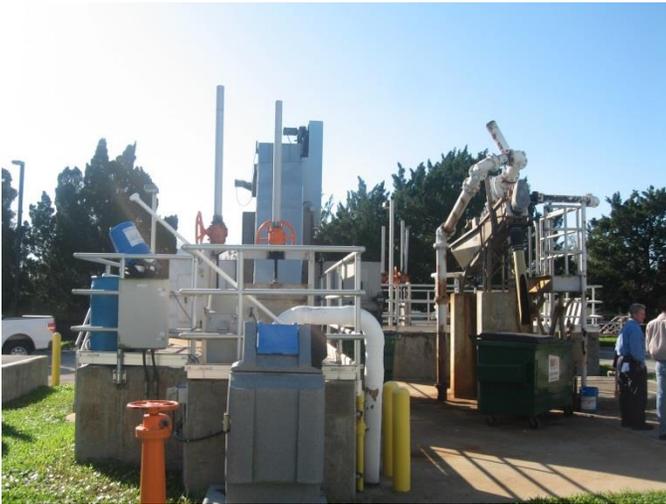
Jerry Sellers Water Reclamation Facility
headworks prior to renovation.

On September 30, 2013, an \$854,000 project was completed at the Jerry Sellers Water Reclamation Facility (WRF) which completely renovated the headworks of the plant. Jones Construction was the contractor for the project.

Cocoa Utilities' Jerry Sellers WRF was converted to a 5-stage Bardenpho process (a biological nutrient removal process) during the last major modification in 1989. Much of the equipment installed in 1989 was at or near the end of its useful service life. CDM Smith, Cocoa's provider of engineering services for wastewater and disposal systems, was tasked with conducting an equipment assessment in 2011. The

The "headworks" of a wastewater treatment plant is the initial stage of the treatment process. The function of the headworks is to remove inorganics such as sticks, stones, rags, plastics, grit and sand from the incoming (influent) wastewater stream. This is done to significantly reduce the plugging and clogging of pumps and pipes, the abrasive action of grit on equipment, and the settling of these materials in downstream tanks and basins. CDM Smith evaluated the equipment within the headworks structure including the bar screen and screenings conveyor, Parshall flume, vortex grit removal unit, grit pump, grit classifier, and slide gates.

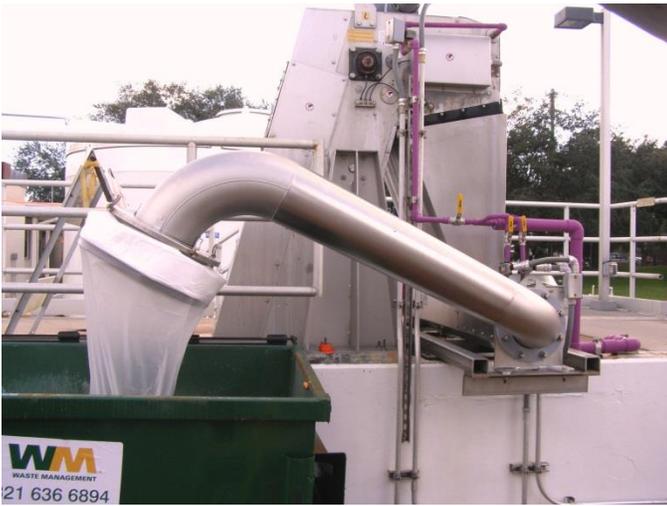
New bar screen, conveyor belt and washer/compactor unit.

Bar Screen and Conveyor System

The existing headworks structure consists of two influent channels. Prior to construction one channel contained a 6 mm mechanical bar screen, while the other contained a manually cleaned bar rack. During normal operation all of the influent flow is directed to the mechanical bar screen. Screenings drop onto a conveyor belt that discharges to a dumpster. The manually cleaned bar rack is only utilized during periods of extreme high flow or extended down-time of the mechanical screen. The existing mechanical screen had reached the end of its useful service life and needed to be replaced. The belt conveyor was also in poor condition. The contractor installed a washer/compactor unit. These units are now the industry standard for processing screenings. The washer/compactor unit consists of a spray system for removing organic material and an auger. The auger reduces water content, and compacts screenings for transport to a dumpster. The existing 6 mm bar screen was replaced with a smaller 3 mm bar screen to increase the capture rate of the screen.

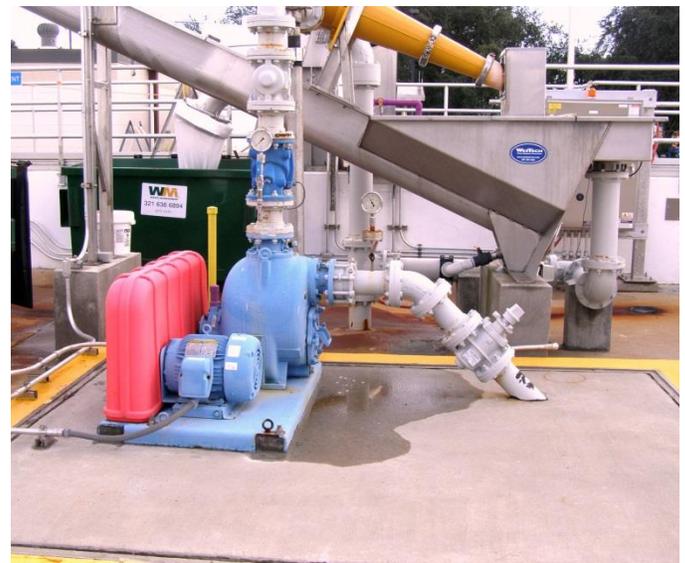
New grit pump and grit classifier. The new grit pump sits atop the filled in vault where the old recessed-impeller pump was housed.

The grit removal system at the Jerry Sellers WRF is composed of three primary components; the grit removal vortex unit, grit pump, and grit classifier. The vortex unit was making excessive noise, an indicator of energy loss and inefficiency. The drive of the vortex unit was corroded in some areas. The grit classifier showed signs of corrosion, especially in the drive of the unit and was at the end of its service life. It had also become difficult to maintain. Due to their age and condition both were replaced.

The grit pump, prior to construction, was a recessed-impeller pump that sat in an underground vault to maintain a flooded suction, which is required for this type of grit pump. The below-grade vault was a confined space as defined by OSHA; and presented a

safety hazard when the pump needed servicing. Cocoa decided to replace the recessed-impeller pump with an above ground grit pump that uses a self-priming vacuum system. The vault was filled in and abandoned thus eliminating a safety concern.

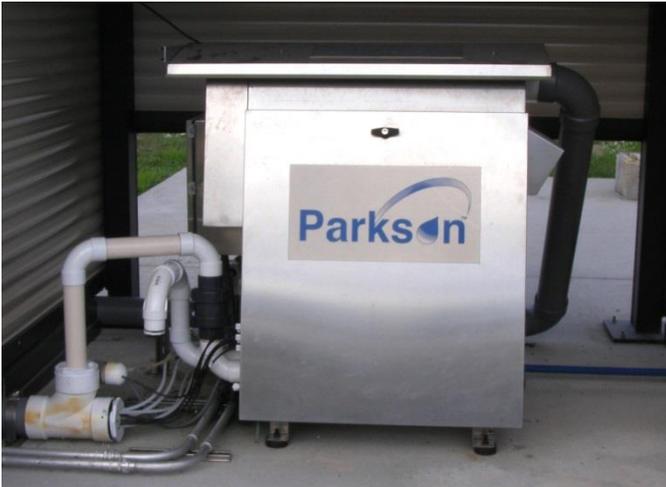
New ozone generator/odor control.

Odor Control System

The old odor control system was not effective in reducing odor and hydrogen sulfide concentrations. Cocoa opted to install an ozone system. Ozone is an emerging odor control alternative for municipal wastewater treatment. In contrast to traditional odor control systems where the foul air is pulled from the structure to be treated in a separate vessel, ozone is injected directly into the structure to oxidize hydrogen sulfide and other odor causing compounds. Using ozone for odor control at municipal wastewater treatment facilities is a relatively new application.

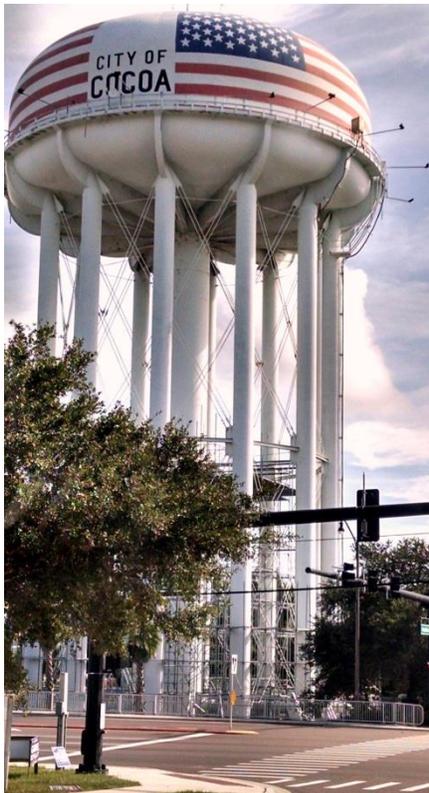
Scaffolding is going up under the elevated tank in preparation for sand blasting and painting.

The steel elevated tank holds up to 1.5-million-gallons and stands 156 feet tall. The elevated tank is used to maintain a constant pressure in the distribution system.

For the current project, the contractor will prepare the structure by masking, removing, or otherwise protecting all hardware, machined surfaces, nameplates and other

surfaces not intended for painting. The contractor will clean and prepare the steel surface by detergent washing to removal all salt spray contamination, followed by an abrasive blast cleaning to near-white metal standards. Removing all the old pain will require approximately 350,000 pounds of abrasive blast media. The contractor must provide containment during the entire blast and painting operation.

After blasting the contractor will apply a series of coatings beginning with an organic zinc-rich primer, then a high-build epoxy, followed by a fluoropolymer finish. It will take approximately 750-800 gallons of Tnemec's finest products to protect the structure.

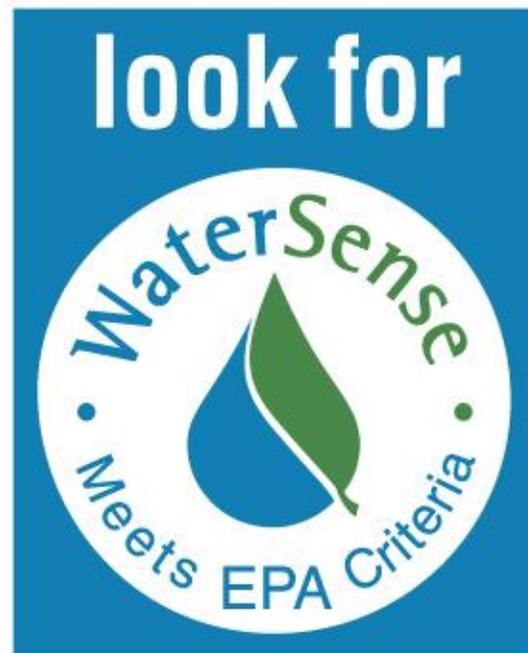
How much water toilets use per flush

Toilet water use can vary significantly. Older toilets can use 3.5, 5, or even up to 7 gallons of water with every flush. Federal plumbing standards now specify that new toilets can only use up to 1.6 GPF, and there

are high efficiency toilets that use 1.28 GPF. Replacing an older model toilet with a new low-flow (1.6 GPF) or high efficiency toilet (1.28 GPF) can greatly affect your household's total water usage and save you money on water and sewer bills.

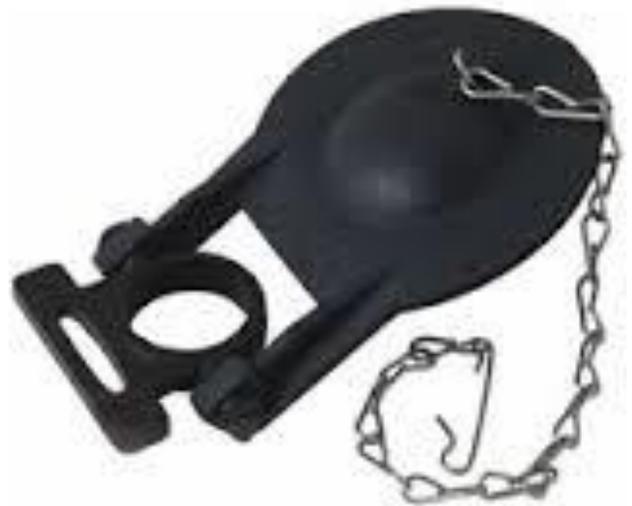
sometimes all it takes to make it work is to clean it &/or the rim where it seats.

- Run a finger carefully around the underside of the flapper and the rim where it seats. Remove any uneven buildup of minerals that might cause a leak. Use a sponge with bleach or steel wool or #500 wet-or-dry abrasive paper.

- The most common cause of slow leaks is a leaky flapper. Over time, this inexpensive rubber part may decay or get old and stiff to the point that it needs replacing, or minerals may build up on it and/or the rim of the flush valve where it seats.
- If the flapper is still in good shape,

Cleaning may work to remove mineral buildup, but it's usually best just to replace the whole part. To perform a replacement:

1. Close the water valve and flush the toilet. If the valve is completely closed, the tank will not refill and you will not hear water running after the tank empties.

2. Pop the old flapper off its hinges, disconnect it from the chain, and pop the new one into place.
3. Don't forget to open the valve all the way when you're ready for water again.
4. Try flushing a few times to make sure the chain is the right length for the new

flapper. It should open when you push the handle and then drop closed all the way when the tank empties. You may have to trim and adjust the chain by trial and error. Also, make sure that the flapper aligns properly with the opening.
